The Next Level for Thermal Performance

Deceiving Deduction?

by Frank Todd, Manager,
Thermal Performance

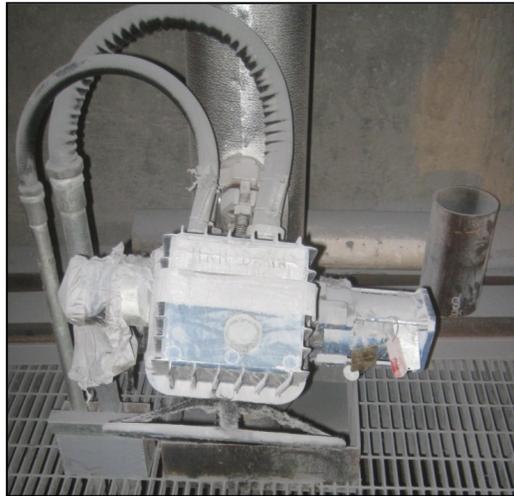
Figure 3. Pipe running under grate

“Well, as I was walking down the pipe I noticed that it dipped below the deck plates (see Figure 3) just a few feet after the valve then popped back up again,” Ritchie explained. “I immediately wondered what was under that deck plate.

“I went down to the lower level and noticed a nice shiny new pipe coming into the pipe we were monitoring,” he said. “I walked it all the way down and found the bypass line with the

orifice.”
